Implementation of a Comprehensive On-Line Closed-Loop Diagnostic System for Roll-to-Roll Amorphous Silicon Solar Cell Production

**Annual Report, Year Two
1 September 2003—31 August 2004**

T. Ellison
*Energy Conversion Devices, Inc.
Troy, Michigan*

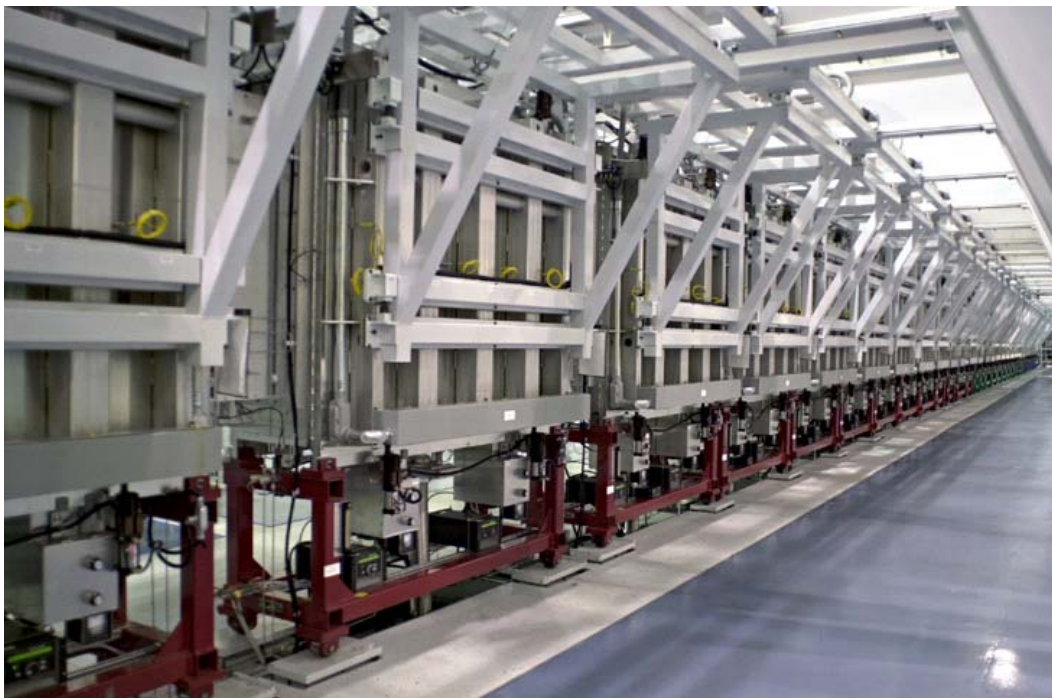
Fig. 2. Side view of the United Solar 30 MW/yr a Si processor.

Energy Conversion Devices, Inc. (ECD) has developed and built 7 generations of roll-to-roll amorphous silicon PV production equipment. In the ECD/United Solar Ovonic production process we deposit about a 1 μm -thick 12-layer coating consisting of a metal/oxide backreflector, a 9 layer a-Si/a-SiGe alloy triple junction solar cell, and a top transparent conductive oxide coating onto 125 μm thick, 35.5 cm wide stainless steel webs in a series of three roll-to-roll deposition machines. Figure 1 shows a schematic of the United Solar 30 MW a-Si deposition machine; a photograph of the machine is shown in Fig. 2.

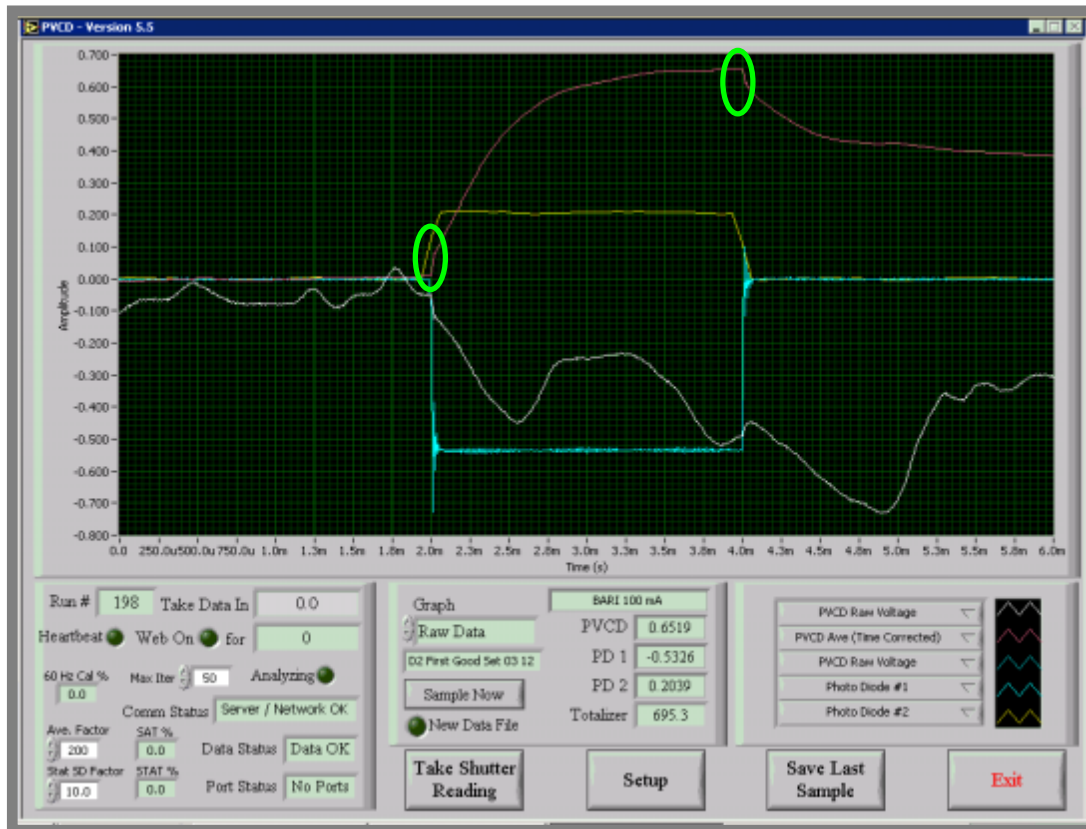
Fig. 2.6. Raw data from middle (component) cell PVCD soon after installation. The 4 traces are as follows: Blue and Gold: signals from photo-detectors showing the light pulse. The blue signal has 10 times the bandwidth as the gold signal. White and Red signals: the white signal shows the last (raw) data take from the detector; the red signal has is the average taken over the last 5 minutes.

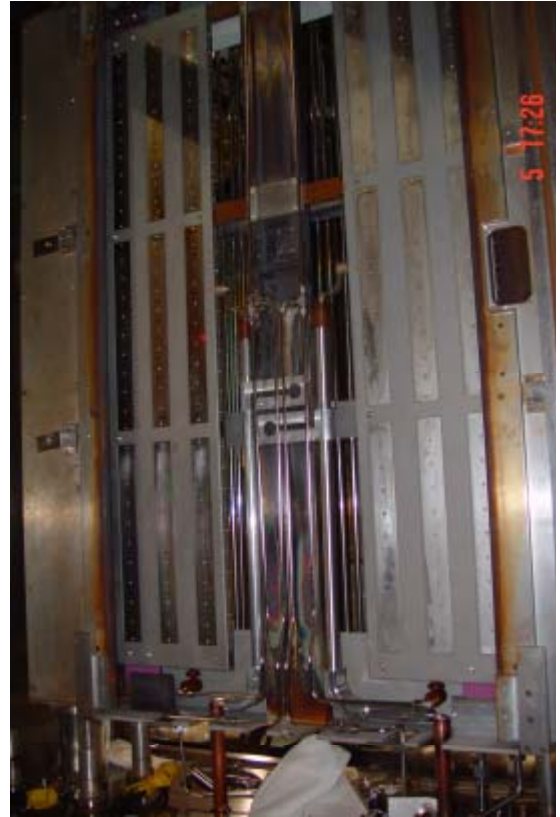
Fig. 3.1. Photograph of the test chamber showing the newly-installed p-type cathodes and gas lines.

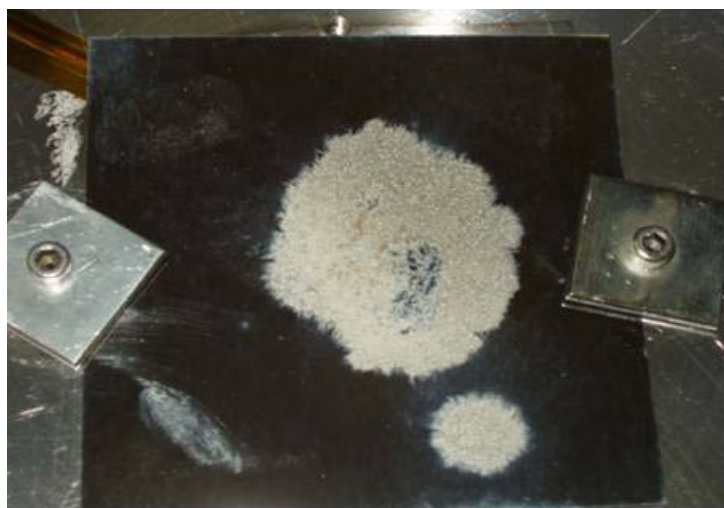
Fig. 4.4. Thick oily film after extended plasma treatment.

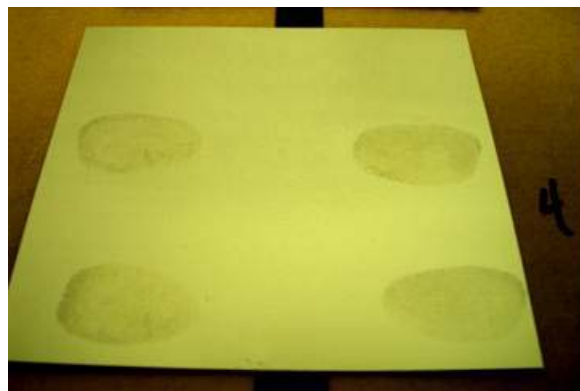
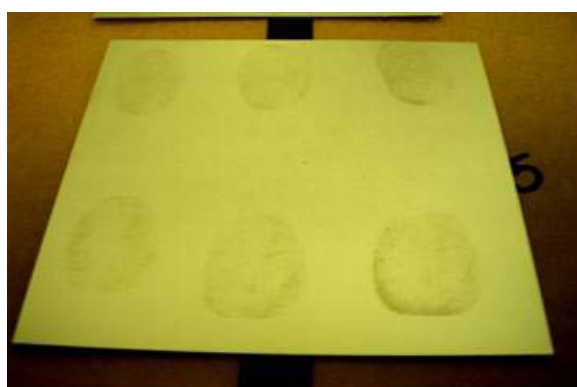
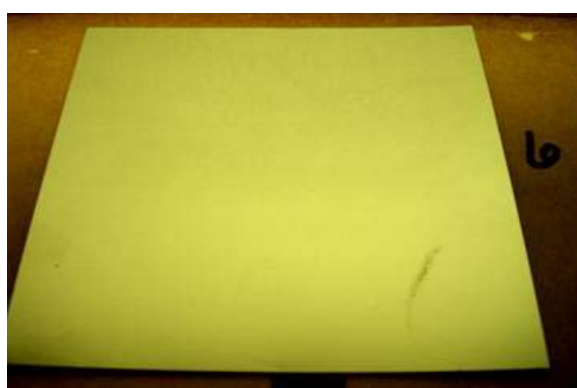
Fig. 4.8 – Ar+O₂ plasma, 5 seconds

Fig. 4.9 – Ar+O₂ plasma, 15 seconds

Fig. 4.10 – Ar+O₂ plasma, 30 second

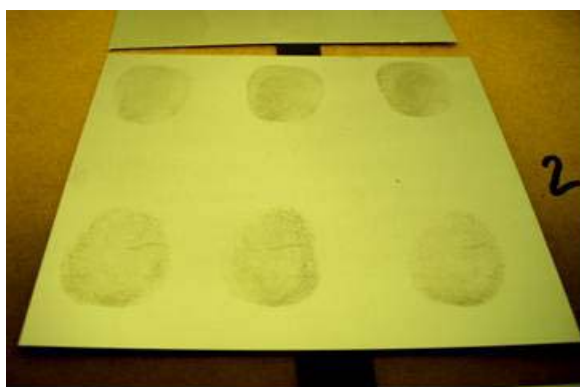
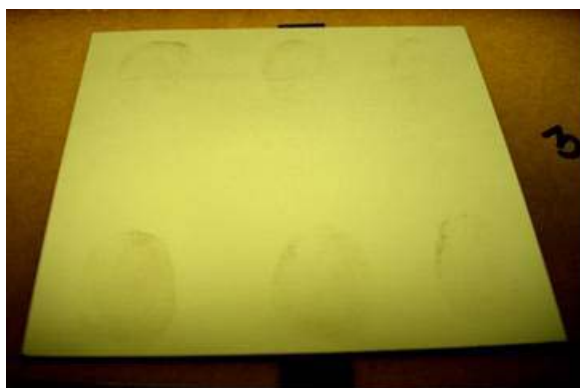
Fig. 4.5 – Ar plasma, 5 seconds

Fig. 4.6 – Ar plasma, 15 seconds

Fig. 4.7 – Ar plasma, 30 seconds

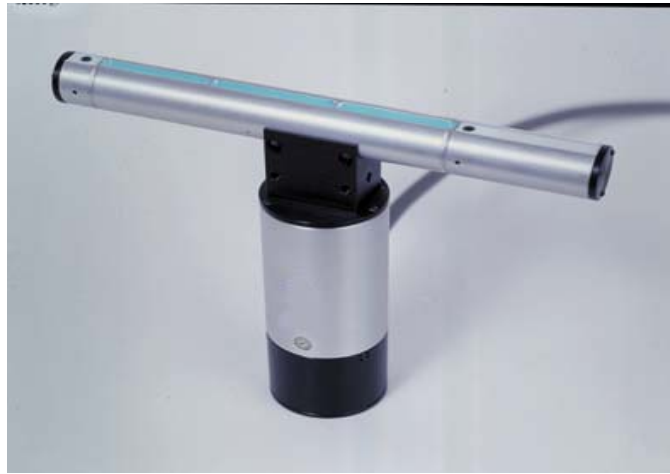
Fig. 4.11. The PET 6-in wide OSEE sensor head used in the Pay-Off and Take-Up chambers of the 30 MW Washing Machine.

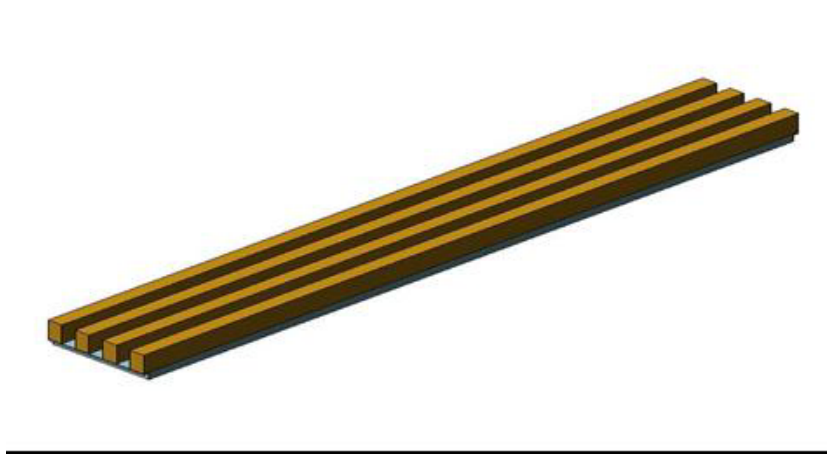
Fig. 4.16. Ribbed anode assembly

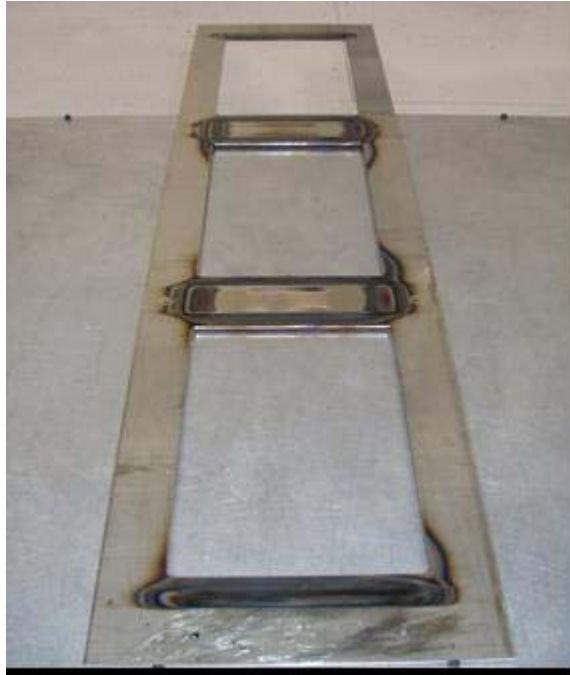
Fig. 4.17. Inner surface of the confining mask

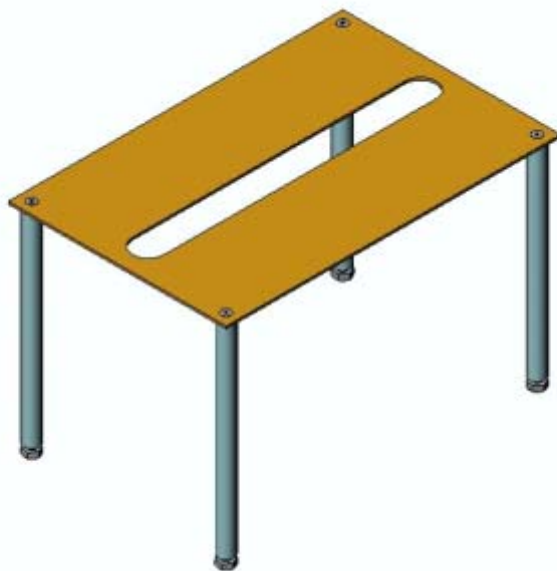
Fig. 4.20. OSEE sensor sample table.
